Figure 2c (to FER-239). 1988 Official Special Studies Zones Map of the Galway Lake quadrangle, showing surface fault rupture associated with the 28 June 1992 Landers earthquake. Faults shown in red or highlighted in yellow are recommended for zoning (revision) for Special Studies.

STATE OF CALIFORNIA SPECIAL STUDIES ZONES

GALWAY LAKE QUADRANGLE

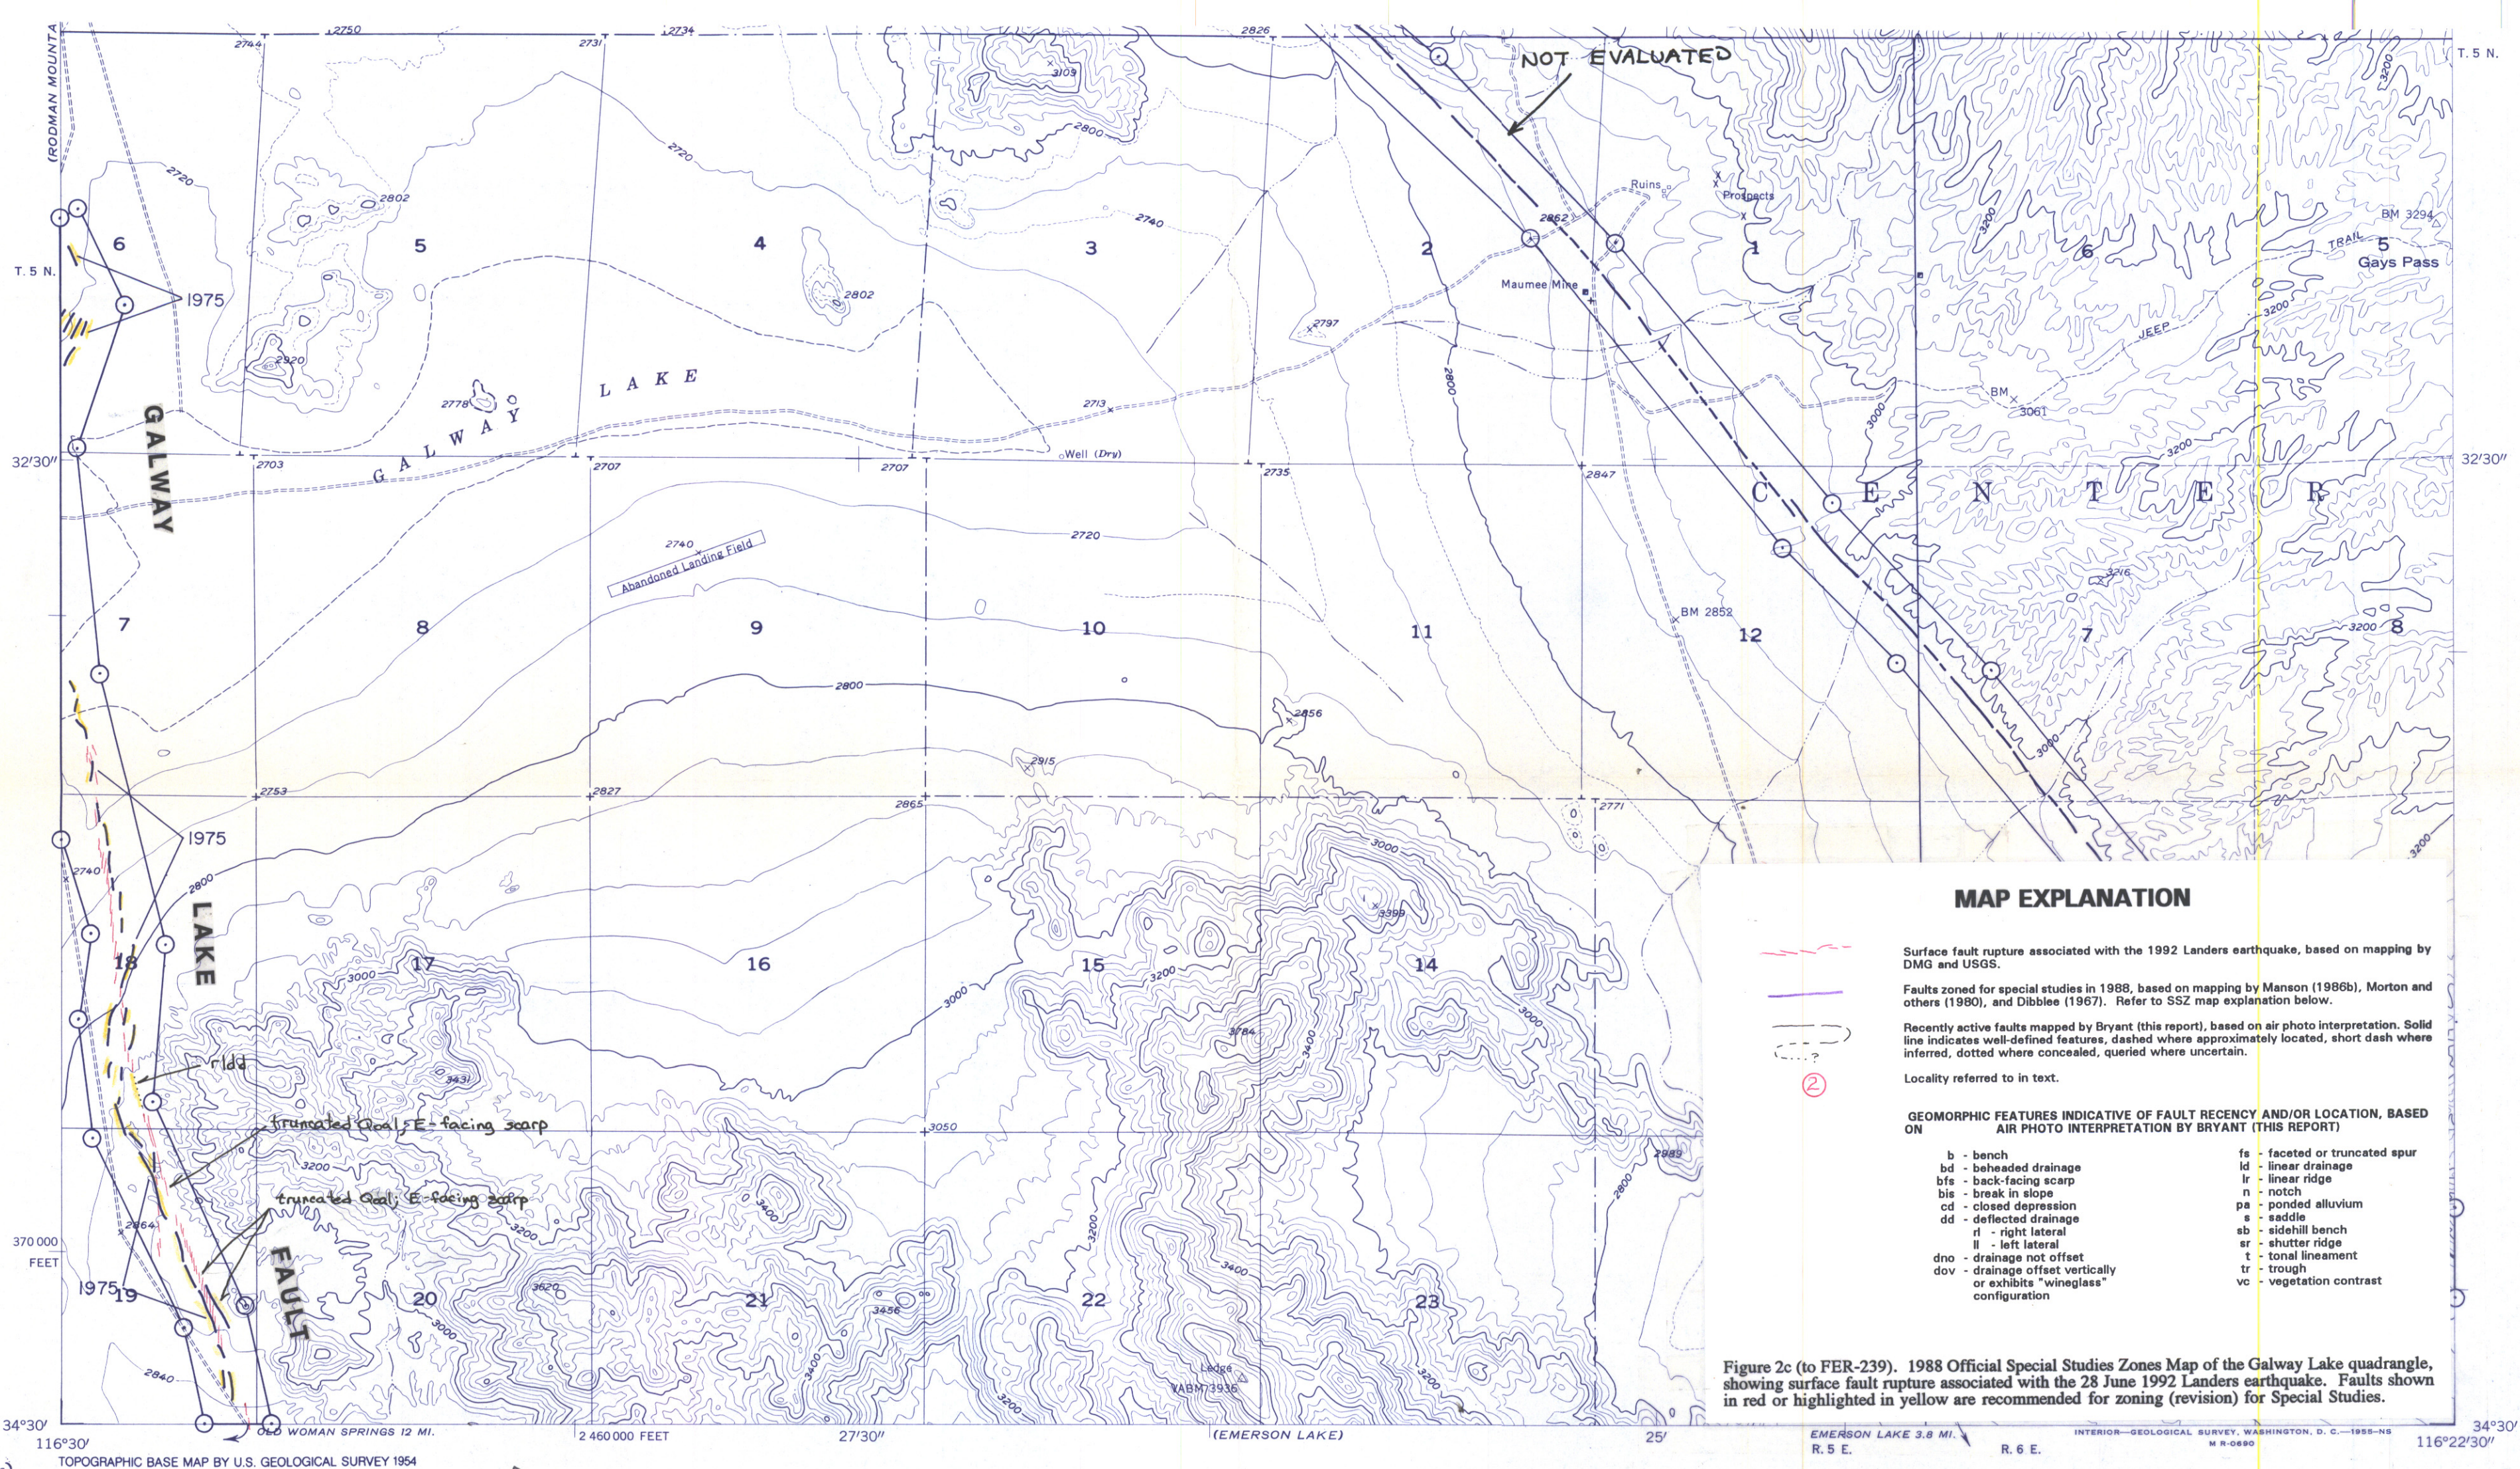
Surface fault rupture associated with the 1992 Landers earthquake, based on mapping by DMG and USGS.

Recently active faults mapped by Bryant (this report), based on air photo interpretation. Solid line indicates well-defined features, dashed where approximately located, short dash where inferred, dotted where concealed, queried where uncertain.
